**CANON LASER PRINTER
TONER CARTRIDGES FOR RUSSIA
(CRG-718)
PRINTS COMPARISON TEST
SUMMARY REPORT**

Canon Laser Printer, Toner Cartridges for Russia (CRG-718) Prints Comparison Test Summary Report

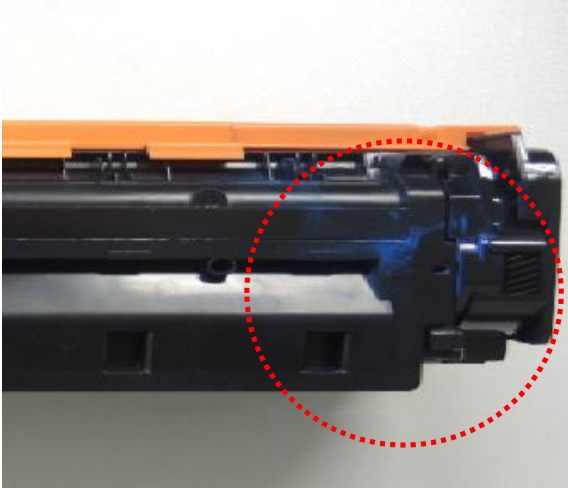
Cartridge	Cyan	
NV PRINT No. 1

Given below are the images of the scattered toner when the toner cartridges of NV Print were unpacked.

<p data-bbox="277 1137 823 1198">Scattered toner was recognized on the upper right side</p>

The toner cartridges of Canon genuine, Cactus, and NV Print were checked for packing condition and the condition on unpacking. No defective conditions of packing, including the outer box, were found for any of the toner cartridges. When the toner cartridges were unpacked, scattered toner was found on one NV Print toner cartridge (cyan). Scattered toner was not found on the other toner cartridges, including those of Canon genuine and Cactus.

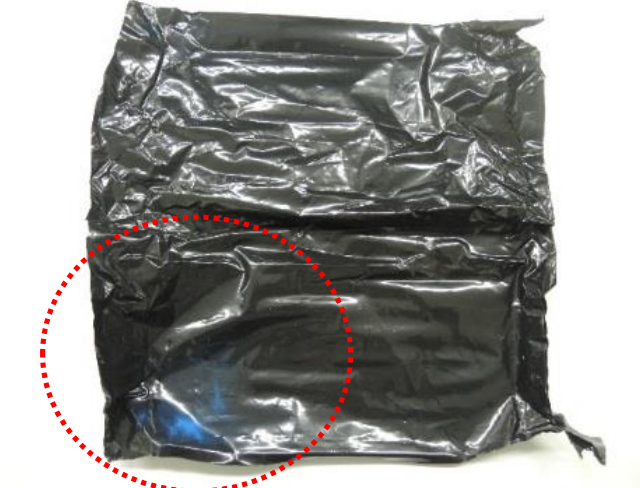
<p data-bbox="871 1137 1497 1198">Scattered toner was also recognized in the inside of protective bag</p>

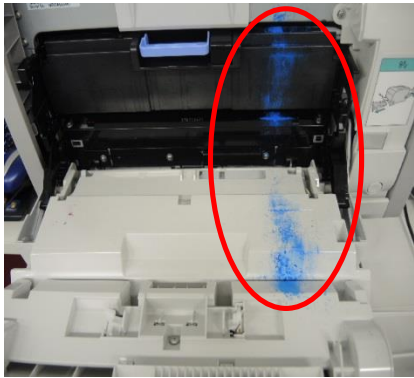
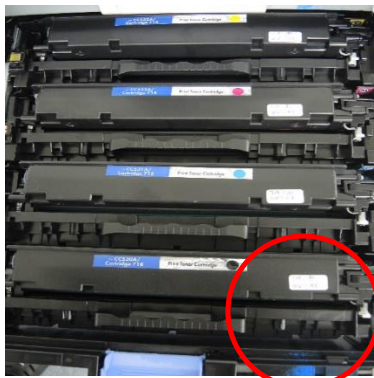
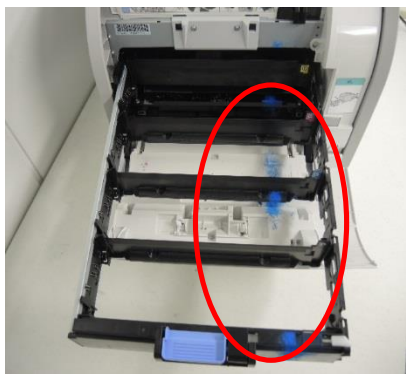
Figure (3): Stain on the CRG mounting position

Stain on the CRG mounting position			
NV Print	CRG mounting position	CRG fitting position	View when CRG is detached

Figures (1) and (2): Stain on the printed image, Figure (3): Stain on the CRG mounting position, Figure (4): Stain on the printer rear roller, Figure (5): Stain in the inside of the printer, Figure (6): Overall image with remaining sheets

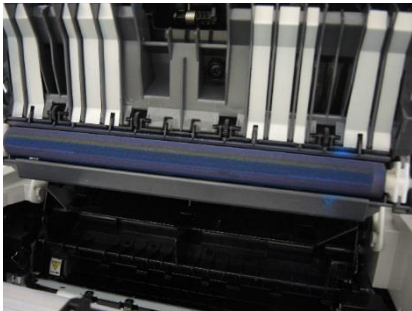
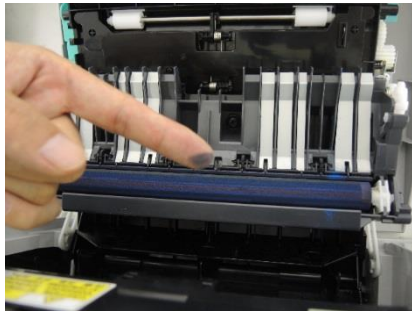
Figure (4): Stain on the printer rear roller

Stain on the printer rear roller		
NV Print

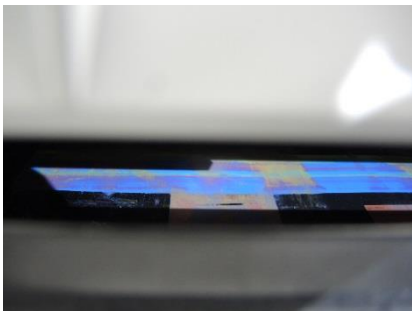
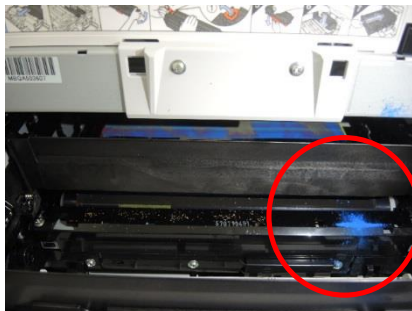
Figure (5): Stain in the inside of the printer

Stain in the inside of the printer		
NV Print

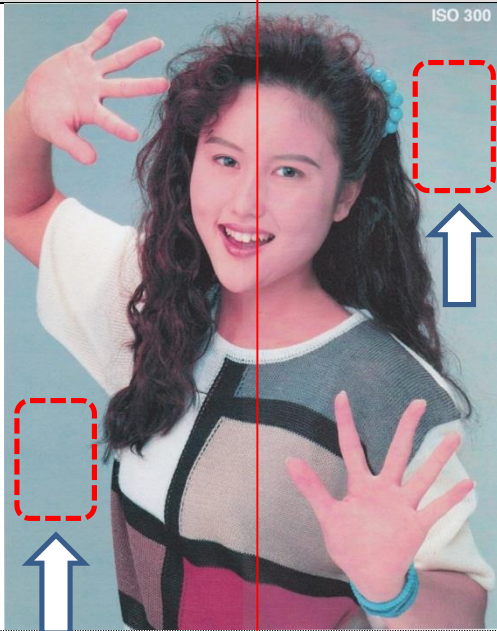
Color hue comparison after 500 sheets were printed; the left half Canon genuine image is combined with the right half non-genuine image.

<p>Color is light compared with Canon genuine (red frame)</p>

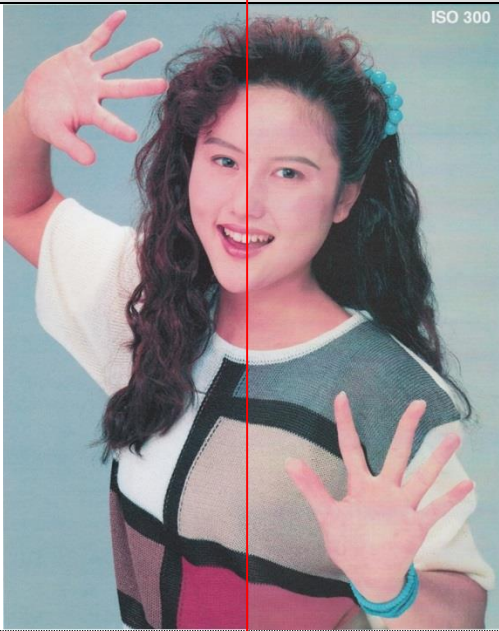
<p>Color is pale compared with Canon genuine</p>

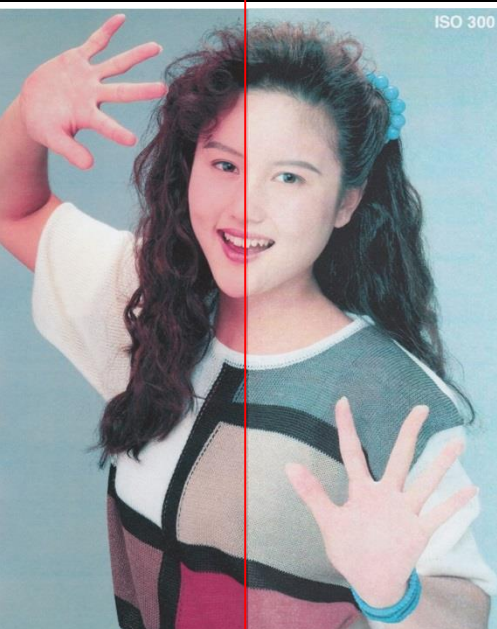
Color hue comparison after 4,500 sheets were printed; the left half Canon genuine image is combined with the right half non-genuine image.

<p>Color hue is distinctly unusual compared with Canon genuine</p>

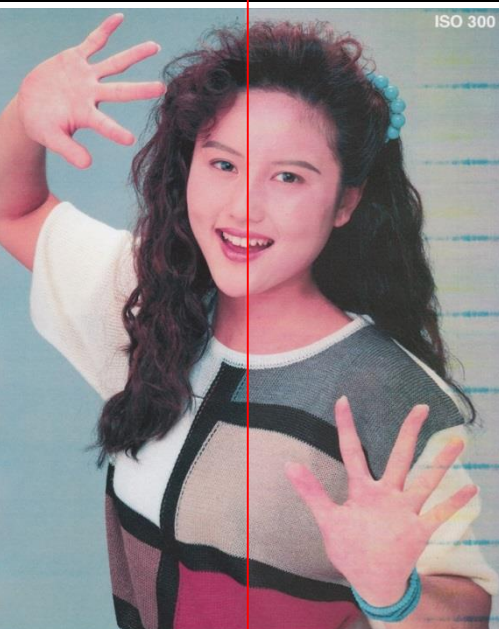
<p>Color is yellowish compared with Canon genuine, and stains are recognized</p>

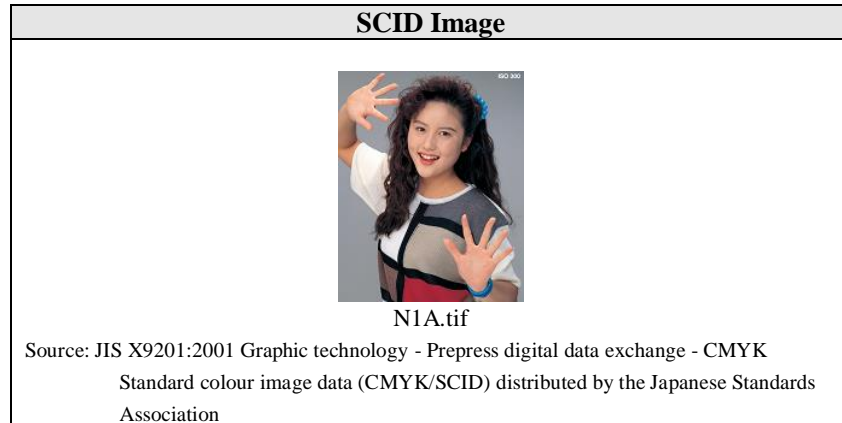
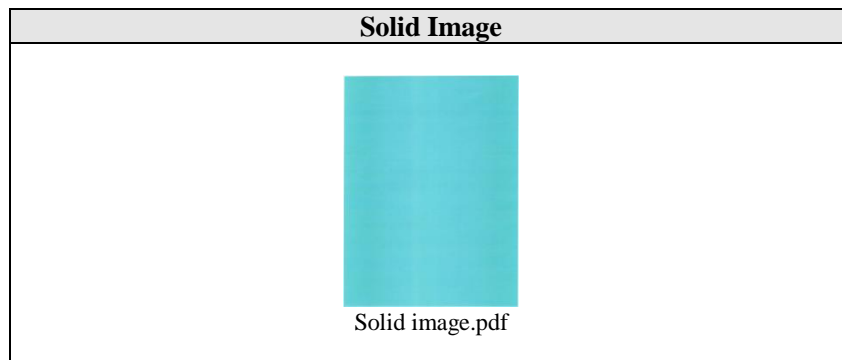
- Print image data: SCID image N1A and solid image (for print assessment of print image quality)
